NUC TP 268
Rev. 1

PROJECT QUICK FIND: A MARINE MAMMAL SYSTEM FOR OBJECT RECOVERY

by
Martin E. Conboy
Ocean Sciences Department
June 1972

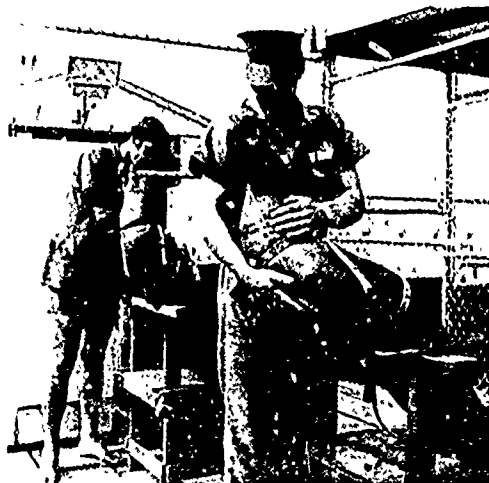
Figure 3. Harnessing position.

Early in the training the animals were conditioned to climb onto a training stand and to remain in the position indicated in Fig. 3. It is in this position that the muzzle and harnessing behaviors were introduced to the animals. Every day the animals' work began by being harnessed on the training stand. By climbing onto the stand, the sea lion was elevated to a more convenient level for harnessing by the trainer. The harnessing phase consisted of first having the animal allow a 10-inch-diameter rubber hose ring to be placed over his head and then around his neck. After several trials the hose ring was eventually replaced by the neck band of the harness, which was left on the animal for a short period of time. After this was accomplished successfully the snaps and belts were loosely coupled and, again after a period of adjustment, were tightened. The harnesses were left on overnight initially, but one animal became entangled in the fence of the communal swim area, and this practice was discontinued. The harnessing of the animal allowed the trainer to walk the animal as he would a dog (Fig. 4) and to thus lead him into unfamiliar areas if required. Also the open-ocean or open-bay training could be accelerated considerably by working the animal on a tether tied to the harness.

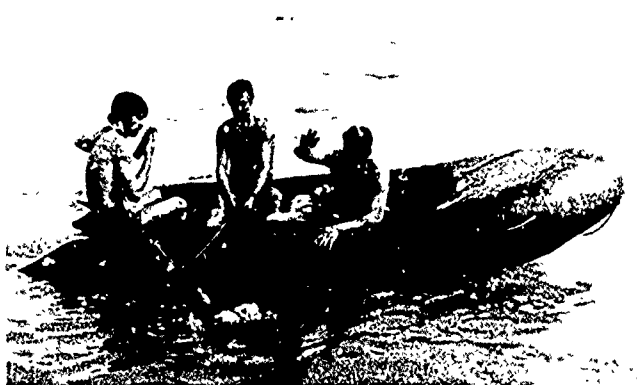
Figure 9. Ocean training session.

The training session began by placing the target at the desired depth by rope. The target was lowered by hand to ensure that it would be upright on the bottom. Then the first animal to be worked, along with his trainer, a boat driver, and a line handler would get into the rubber work boat and drive a short distance away. After the animal was signaled into the water for hear-tell he then returned to the work boat to report. The pinger in the target could be remotely controlled from the barge, and the work boat driver served as radio operator in order to inform the trainer of the pinger's operating condition. After a positive report on the pinger the animal was again signaled to enter the water and to remain near the side of the work boat while the trainer placed the grabber on the animal's head. Figures 9, 10, and 11 show the animal leaving the work boat and placing the grabber on the target. Figure 12 shows a typical ocean training session with the relative positions of the boats.

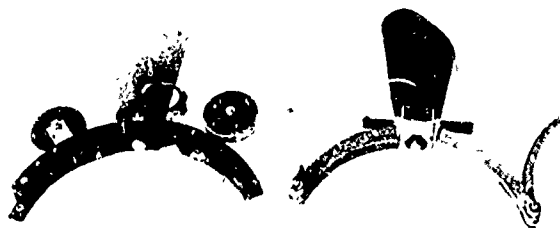
Figure 14. Training grabbers.

Simulated grabbers were constructed while the final grabber design was being perfected. This allowed the trainers and sea lions an opportunity to work with the device and provide feedback to the engineers on its probable advantages and disadvantages. These simulated grabbers had about the same surface area, weight, and configuration as the real grabber. Figure 14 shows two of the training models. The model on the left is a copy of the final grabber; the one on the right is an earlier version that has "wrap around" grabbers. The one on the left simulates a telescoping model. These models were used as training aids because, since they did not require the fine tolerances of the recovery grabbers, they were much cheaper and quicker to fabricate.
